The Application of the Environmental Adaptation Concept to A Collector Road in KKU, Thailand

Abstract

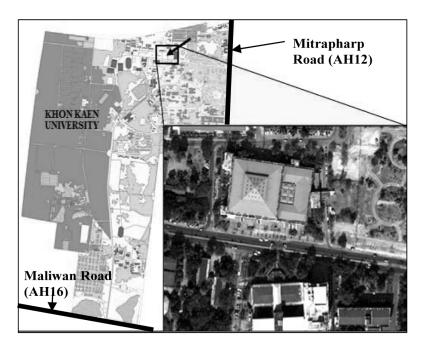
Figure 1 A collector road adjacent to the complex building in Khon Kaen University

(ii) study area specification: a collector road, a divided four-lane road with 1.5 meters median width and narrow footpath as shown in (Figure 1 and 3) in front of the complex building is functioning as the main street in KKU. In addition, the adjacent road network and surrounding land use on both sides of the road were also taken into account; (iii) objectives and strategies identification: the main objectives of this research is to improve road and land use physical characteristics to reduce conflicts between pedestrian maneuverings and vehicles movements (therefore pedestrian accident risk) and to improve the environmental and amenity quality; (iv) performance criteria identification: prior to conducting a detailed investigation of the project. The performance criteria must be identified and selected to assess and evaluate the outcome of proposed alternatives; (v) data collection and analysis: the collected data include physical road and land use characteristics of a collector road, adjacent road network and surrounding land use such as mid-block and intersection traffic volume, Origin and Destination (O-D) traffic data, operating speed, pedestrian crossing maneuvering and others; (vi) developing alternatives of measure schemes: alternatives will be developed in an integrated fashion. Therefore, different control, design and construction measures as suggested in will be properly selected and incorporated as set of different alternatives to be proposed for implementation; (vii) selection of the appropriate alternative: the different alternative were proposed and compared in correspondence to the specified objectives. Then, the appropriate alternative was selected for actual implementation.

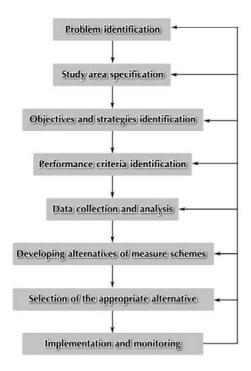
$\textbf{Figure 2} \ \ \textbf{Flow chart diagram of the application process of the EAM concept}$

KKU collector road⁶ and (Figure 2) also shows flow chart diagram of the process. The EAM application processes are as follows: (i) problem identification: based on comprehensive field surveys and data collections of traffic and land use characteristics along a collector road in front of the KKU complex building has been suffered from pedestrian accident risk, traffic environmental impacts, amenity and esthetic and land scape problems;

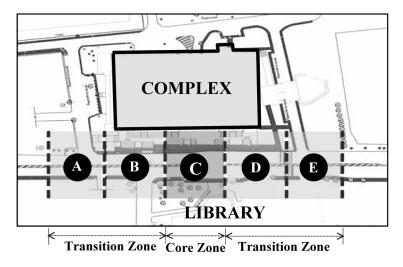
Figuer 4 Five zones of pedestrian crossing data collection

As indicate in (Figure 4) in the before-improvement period at the core zone (C), the traffic flows (collected during 7:30 and 8:30 AM) in the east-bound, west-bound and combined both directions were 577, 610 and 1,187 passenger cars per hour, respectively, while in the first improvement period, the traffic volumes the east-bound, west-bound and combined both directions were 790, 812 and 1,602, respectively. In the second improvement period, the traffic volumes in the east-bound, west-bound and combined both directions were 833, 921 and 1,754, respectively. In the first and second improvement periods, the morning peak hourly (combined both directions) volumes were considerably greater than that in the before improvement period. This was possibly because during the first and the second improvement periods, the certain amount of through traffic attempted to avoid traffic congestion on the existing road network and use the collector road as the short-cut route.

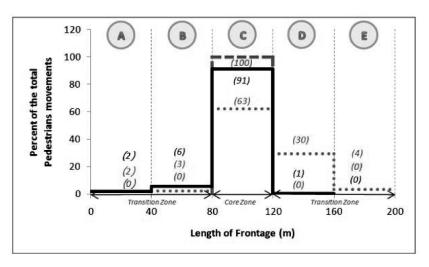
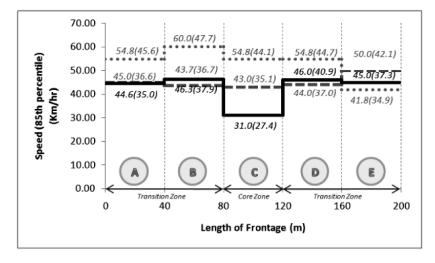
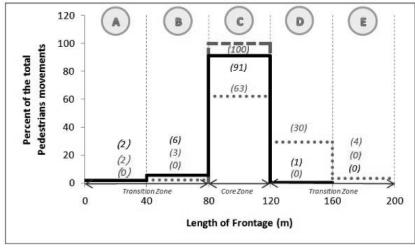
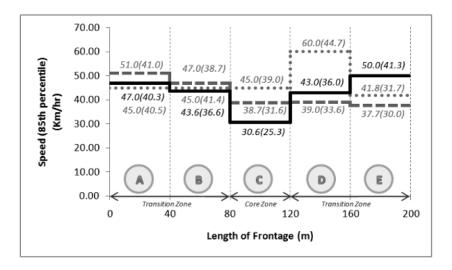
Figure 5 Activity profiles and speed profiles by traffic directions during the before-, the first, and the second-improvement periods

(Figure 5) illustrated the speed profile collected during 7:30 and 8:30 AM in the core zone (C) and the

transition zones (A, B, D and E) during the before-, the first- and the second- improvement periods. In the beforeimprovement period, the 85th percentile speeds in the core zone were 54.8 km/h and 45.0 km/h in the east- and west-bound directions, respectively, while in the firstimprovement period, the 85th percentile speeds in the core zone were reduce to 31.0 km/h and 30.6 km/h in the east- and west-bound directions, respectively. Interestingly, in the second-improvement period, the 85th percentile speeds in the core zone were become 43.0 km/h and 38.7 km/h in the east- and west-bound directions, respectively. It could be concluded that based on the 85th percentile speeds (in both directions) in the core zone, the first- and the second- improvements could potentially reduce traffic speeds dramatically. The results indicated that the installation of a speed hump (in the first-improvement period) can effectively reduce the hazardous speed (in the before- improvement period) to the safer target speed interval (25-35 km/h). McLean et al7 implicitly noted that if a car hit a pedestrian at the impact speed of 50 km/h, the probability of survival is only 7%. However, if the impact speed is reduced to 31 km/h, the probability of survival is greatly raised to 99 %. However, the effectiveness of the improvement in the second-improvement period was lesser than that of the first-improvement period, because of the construction of speed humps during the two improvement periods were physically different in terms of the type of road surface and their physical characteristics (side slopes and heights).

(Figure 5) also illustrated that the pedestrian crossings maneuverings (activity profile) collected during 7:30 and 8:30 AM in the core zone (C) and the transition zones (A, B, D and E) during the before-, the first- and the second-improvement periods. These pedestrian crossings were classified into walking and running maneuvering. As shown in (Figure 7), the percentage of the pedestrian crossings in core zone (C) was increased from 63% (in the before- improvement period) to 91% and approximately 100% in the first- and the second-improvement periods, respectively. In the transition zone (D), the

percentage of the pedestrian crossings was reduced from 30% (in the before-improvement period) to only 1% and 0% in the first- and the second-improvement periods, respectively. In other remaining zones, the percentages of the pedestrian crossings were very low and relatively unchanged during those periods. The results clearly show that the principal achievement of the applications of the EAM concept in gathering as many as pedestrian crossings in core zone (with lower target speeds) and minimizing such crossings in transition zone (with high traffic speeds).
